## Fire & Life Safety Evaluation

Complete
SHSU Campus Name:	Huntsville
Building Name:	Chemistry & Forensic Science Building
Building Number:	300
Conducted By:	Mark Shiflet
Occupancy Type:	Mixed, Assembly & Business
Date of Inspection	May 20, 2024

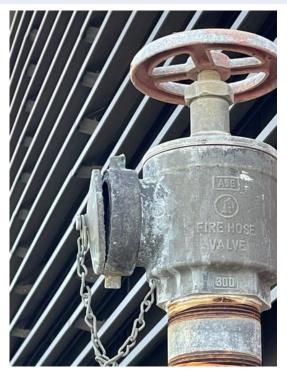
Photo 1

One of the brass caps on the fire sprinkler system test header is broken. Work order 423852 has been created to correct this finding.

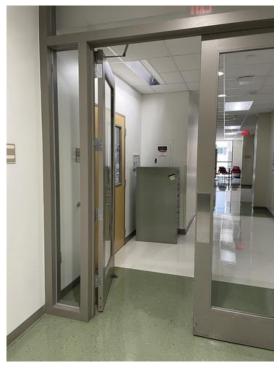
Photo 3

The are several doors on the second & third levels that are held open by door stops. The purpose of these provide a quicker response from the fire alarm and fire sprinkler systems in the event of a fire.

doors is to create compartments within the building to prevent the spread of smoke, heat, and flames and It is the responsibility of the Building Liaison to ensure these door stops are removed.

Work order 423838 has been created to correct this finding.
