ACTIVE LEARNING CENTER

April 2024 · Final Report

A PROGRAM OF REQUIREMENTS FOR THE NEW ACTIVE LEARNING CENTER AT SAM HOUSTON STATE UNIVERSITY

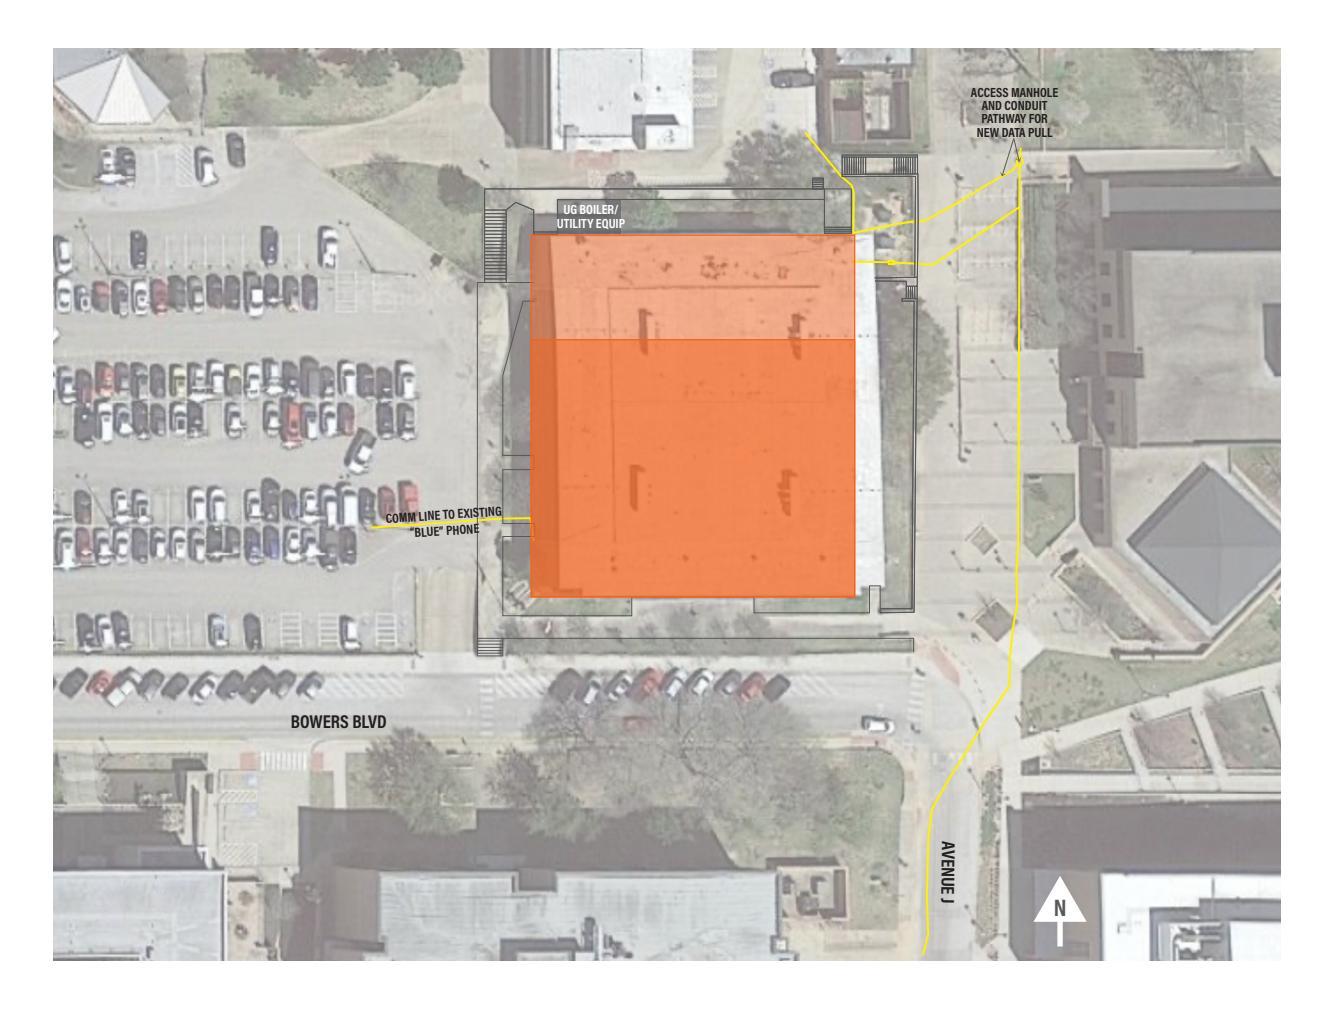
COMMUNICATIONS

Fiber to support the new building is available from the northeast manhole. It is anticipated that the existing pathway will be reused. A new cable (two 12-strand ribbons) will need to be pulled through the existing conduit to connect to the demarcation room in the new facility.

The communication line shown on the west side of the site which terminates in the parking lot supports an existing *blue light* (emergency) phone. The phone will be removed temporarily during demolition and construction, but will need to be replaced along with a new/reconnected line in the parking area as part of the project.

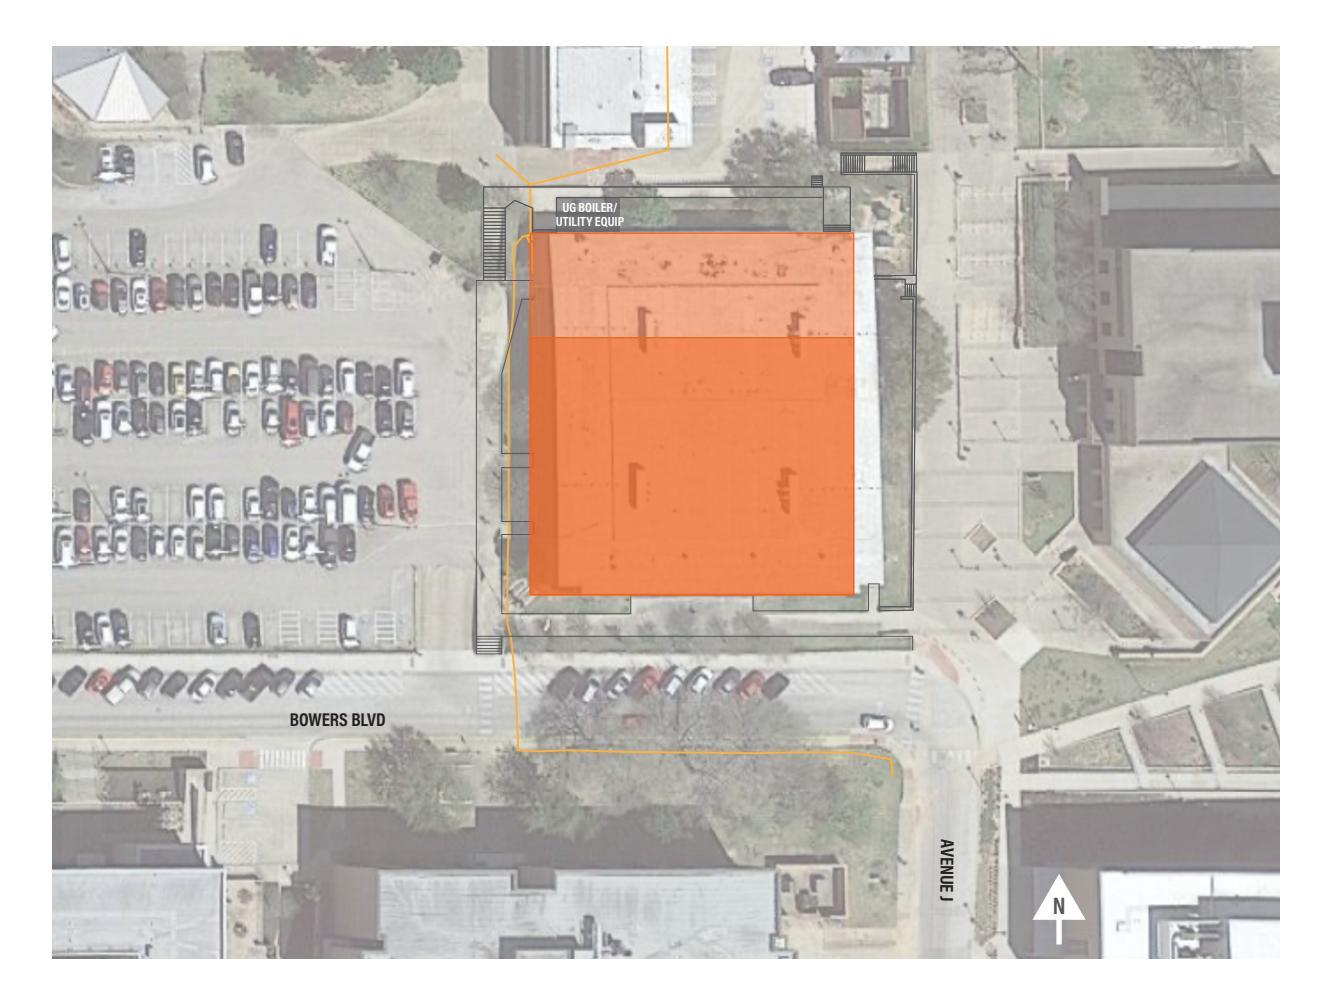
GAS

The Farrington and ABIII buildings are served from a common meter at the northwest corner of the site. The current 2-inch gas line running along the western edge of the site is anticipated to have capacity to serve Farrington and the new building. Service to the Farrington Building must be maintained throughout demolition and construction. A second meter should be provided to serve the new building adjacent to the underground boiler and utility equipment room.

Existing gas meter at northwest corner

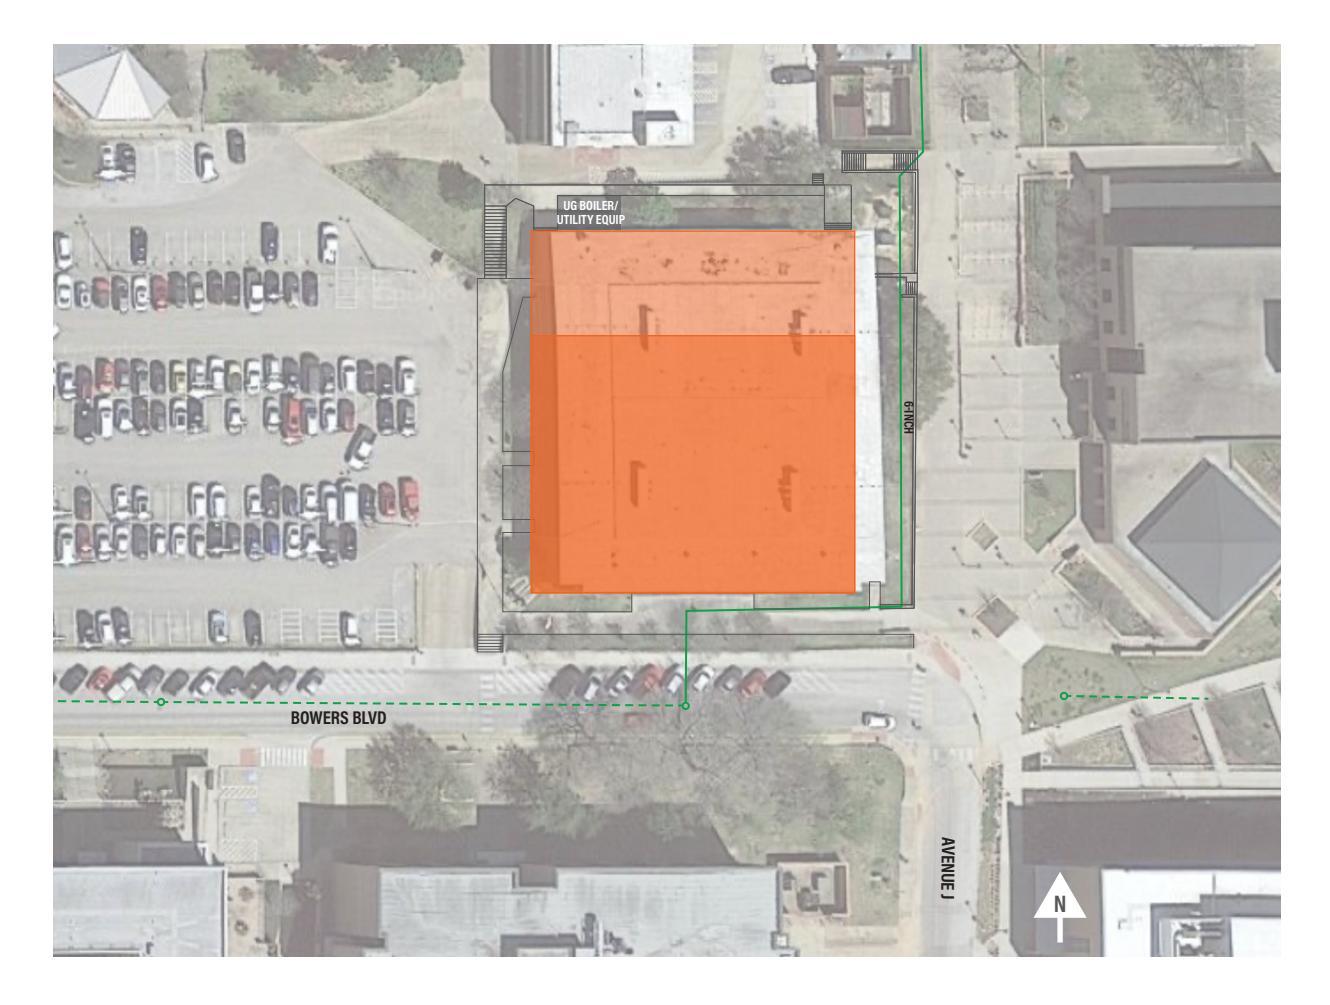
SANITARY SEWER

The project will run new sanitary sewer lines to the City of Huntsville sanitary sewer line directly to the south of the site (running east-west along Bowers Blvd). Existing lines running from the ABIII should be removed as part of the demolition phase of the project.

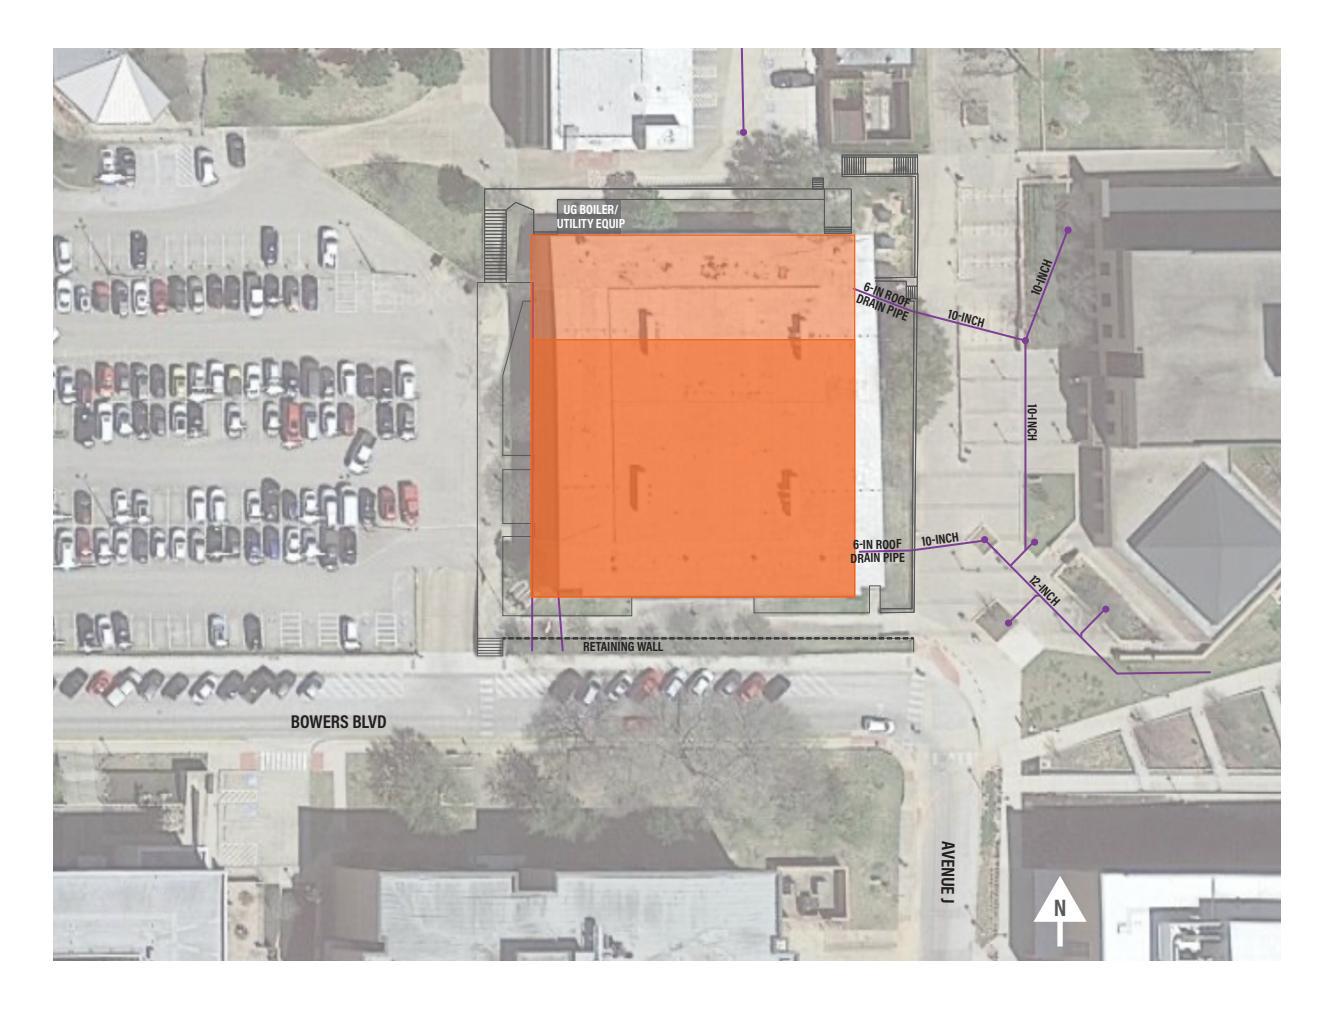
STORM DRAINAGE

Assuming no major alteration to the current topography, storm drainage will continue to be provided via sheet flow along Bowers Blvd. Drainage should be directed south and drained through the retention wall (at the southern edge of the sidewalk to the south of the site) out to Bowers Blvd to the west. There are two existing 10-inch storm drain lines on the eastern edge of the site (at the northeast and southeast) providing storm drainage to the southeast. No storm water detention will be required as part of this project.

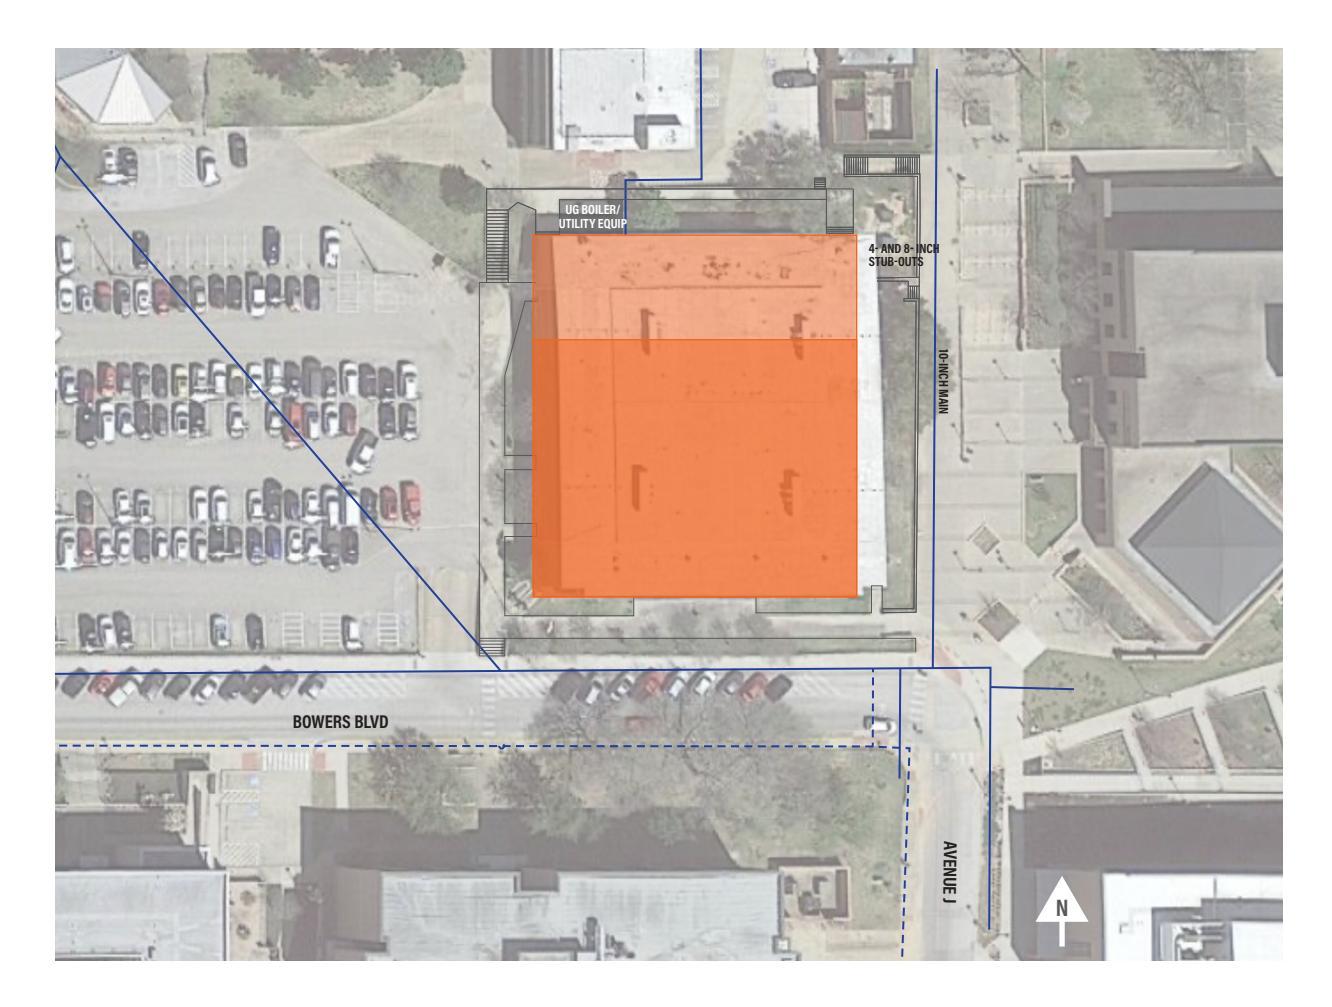
DOMESTIC WATER

There are two stub-outs on the eastern edge of the site near the northern retaining wall (one 4-inch for fire water, and one 8-inch for domestic water). The 10-inch water main which runs north-south along the pedestrian path to the east of the site has adequate capacity to supply the new building.

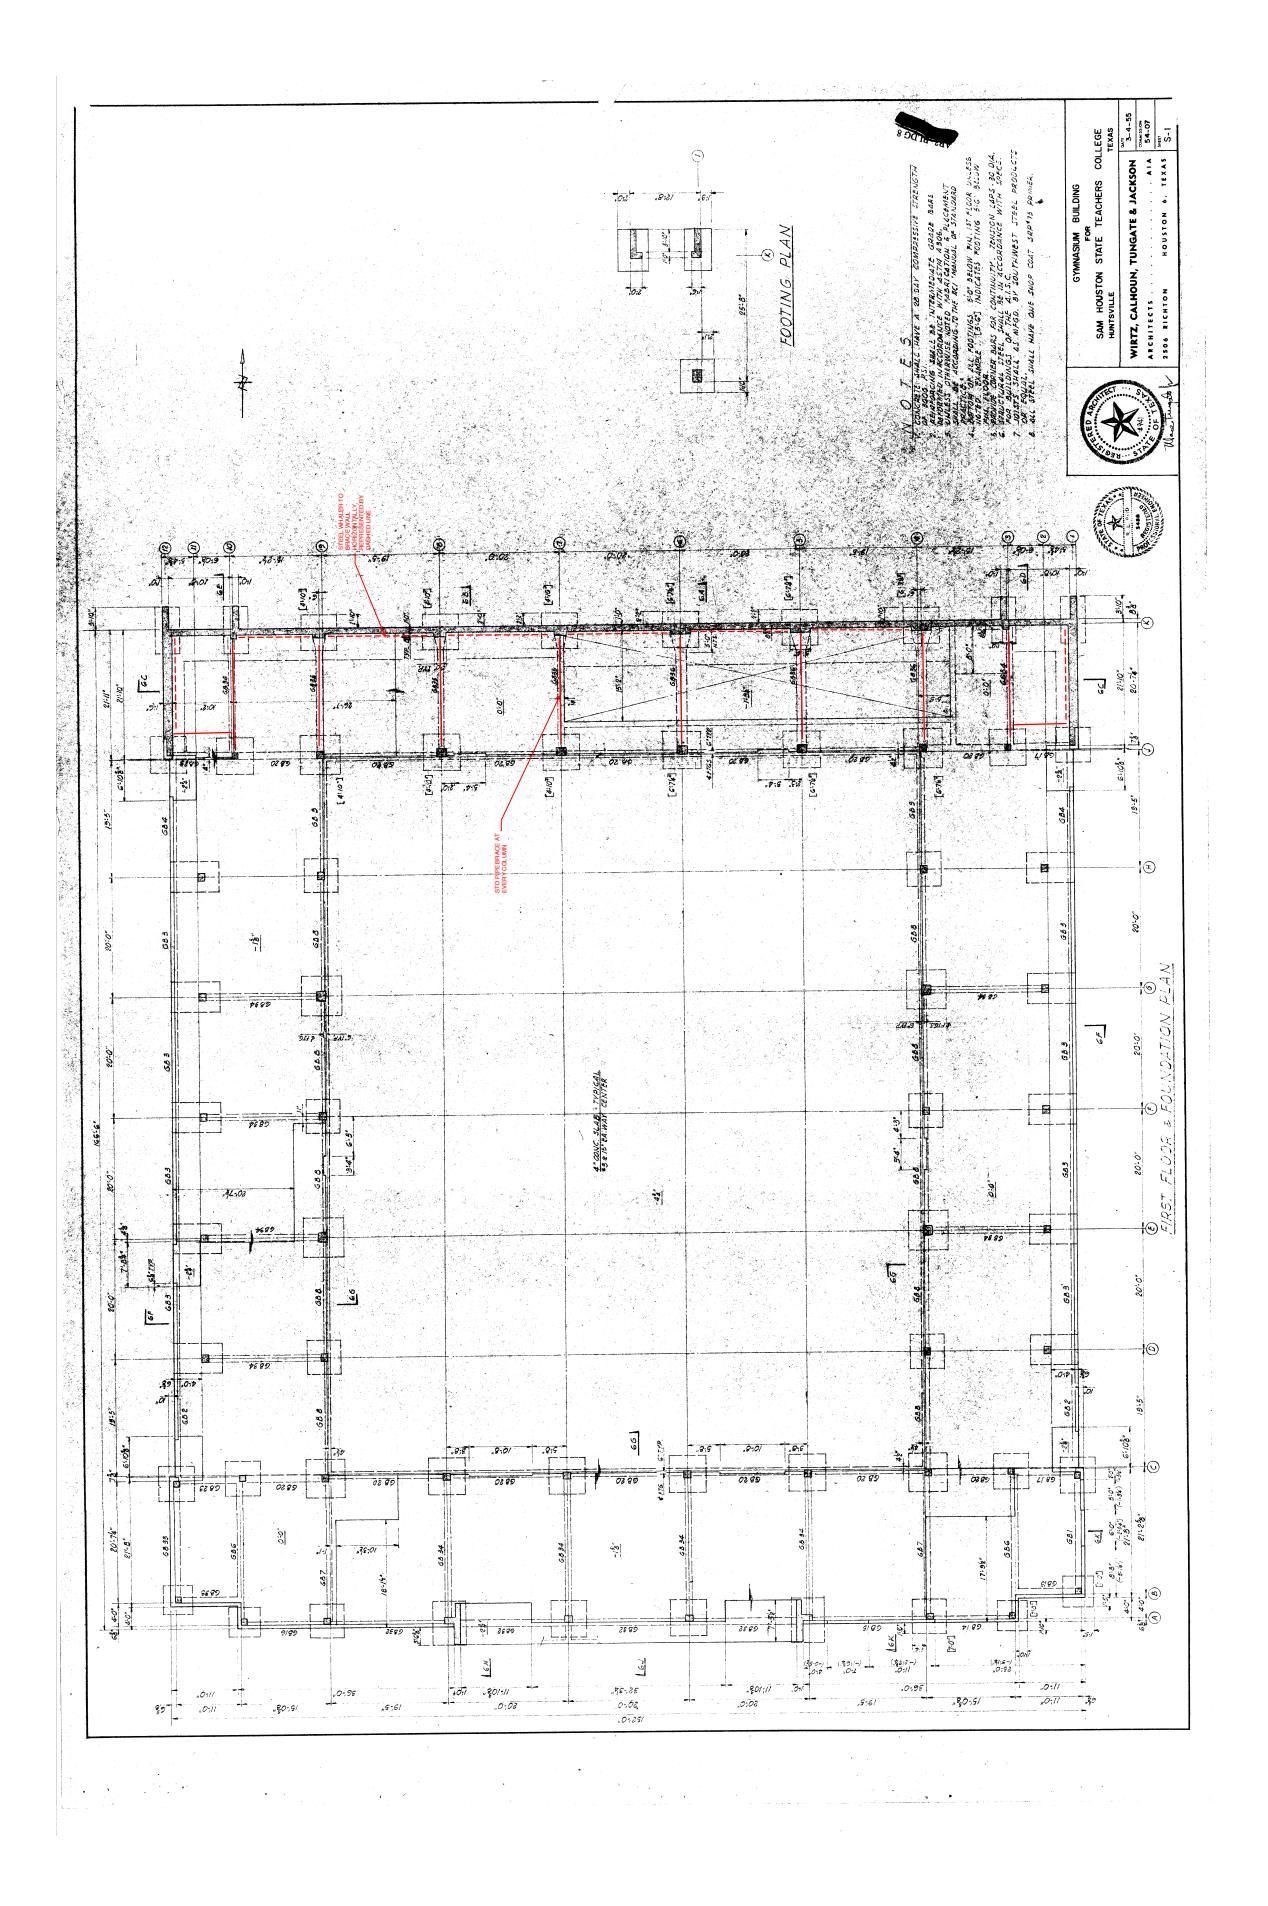
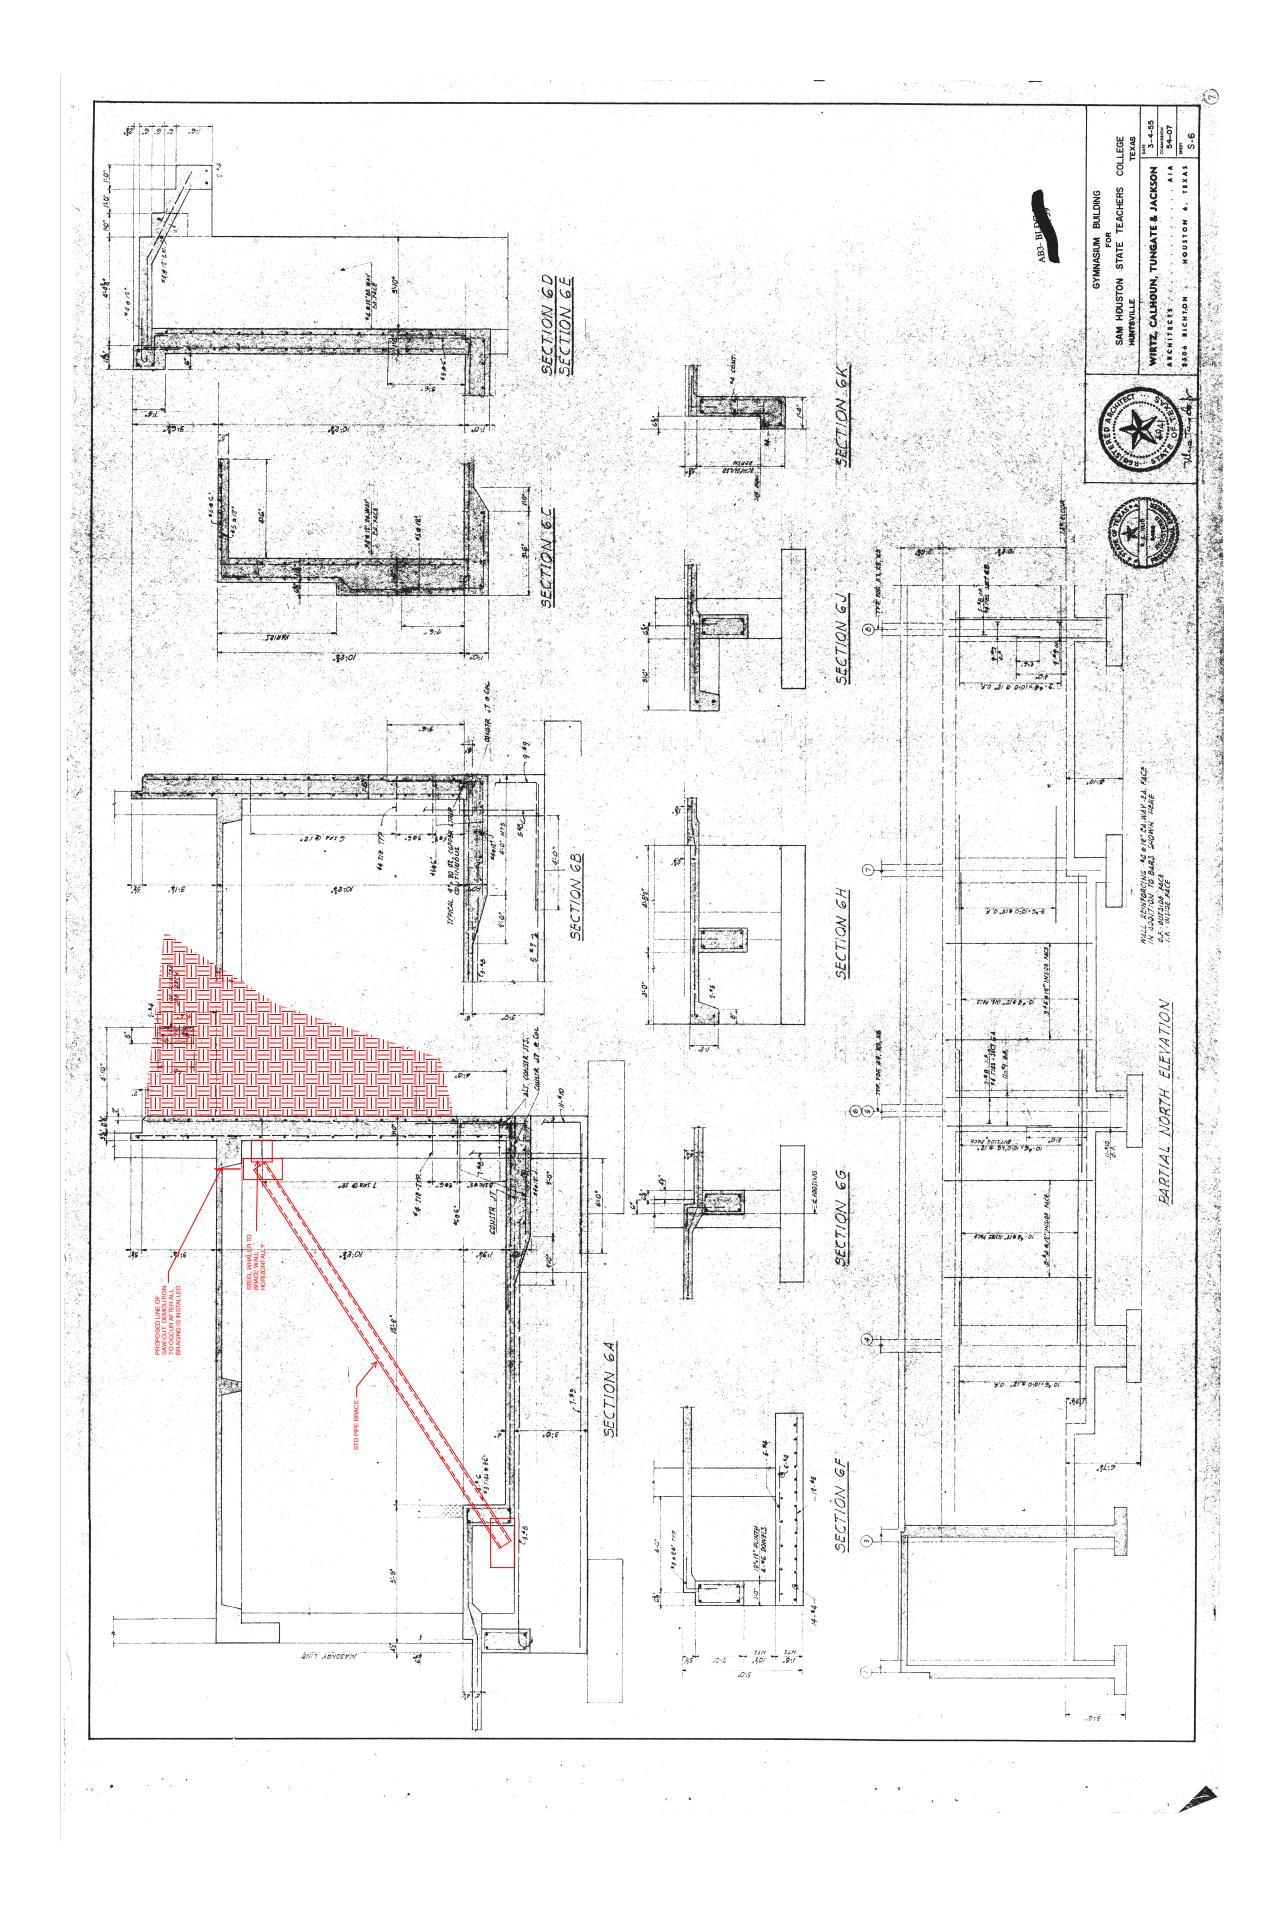
HE EXISTING ABIII LOWER-LEVEL northern wall is reinforced to act as a retaining wall against the 10-foot plus elevation change which occurs at that location. It will be essential to maintain this retaining wall throughout demolition and construction of the new structure. After consultation with a structural engineer, it has been determined that the best course of action is to add additional structural bracing to the retaining wall prior to demolition. This bracing would consist of providing a steel structural waler to brace the wall horizontally and adding standard pipe braces at each of the existing structural columns. After the new bracing is installed, the second floor slab can be saw-cut as part of the demolition. The bracing can be left in place or removed if the new structural system for the Active Learning Center is properly designed and constructed to reinforce/integrate with the retaining wall.

Diagrams of the suggested configuration for the structural bracing is available on the following pages.

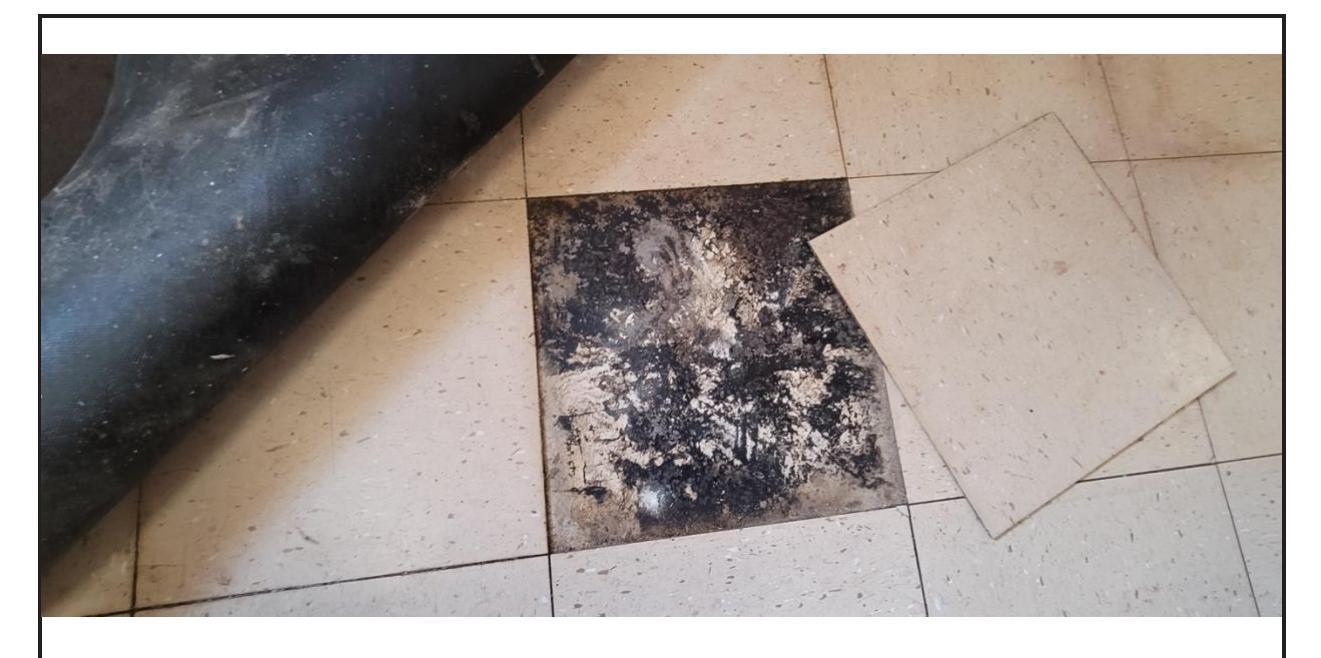
Photo 3: Asbestos containing floor tile and black mastic (100S3).

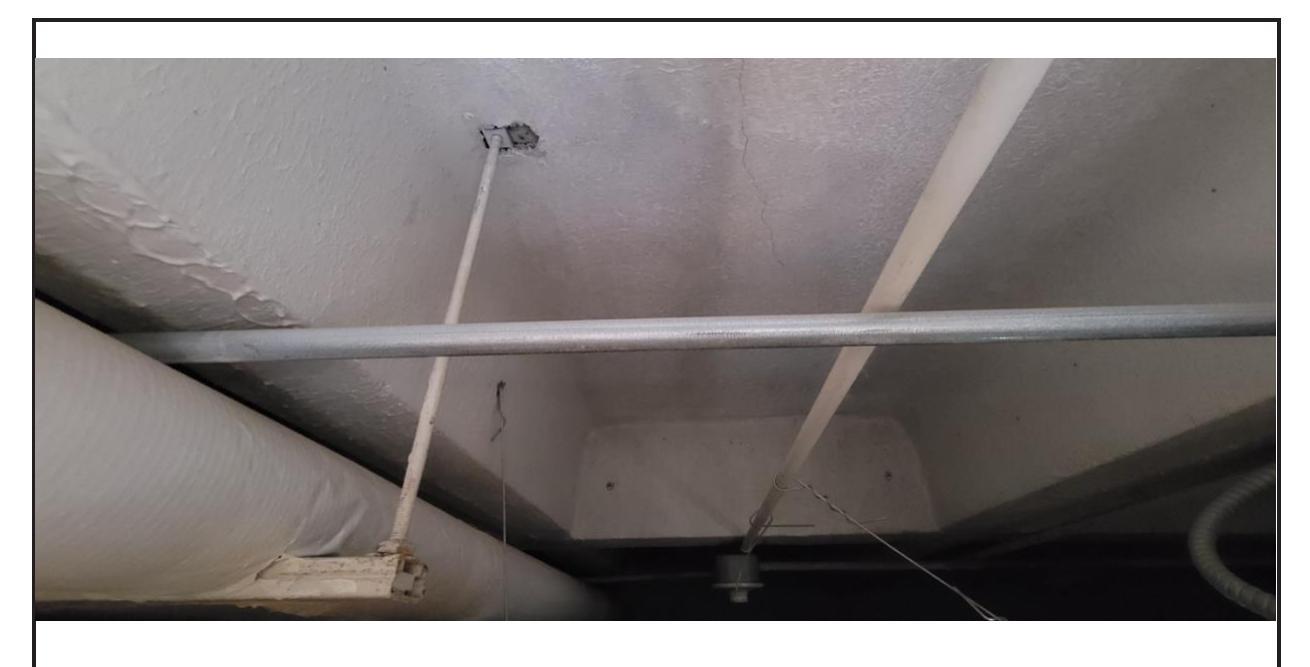
Photo 5: Asbestos-containing concrete ceiling texture (113).

The concrete ceiling and column texture located throughout was found to contain 2% chrysotile asbestos. The material was non-friable and in good condition at the time of the inspection.

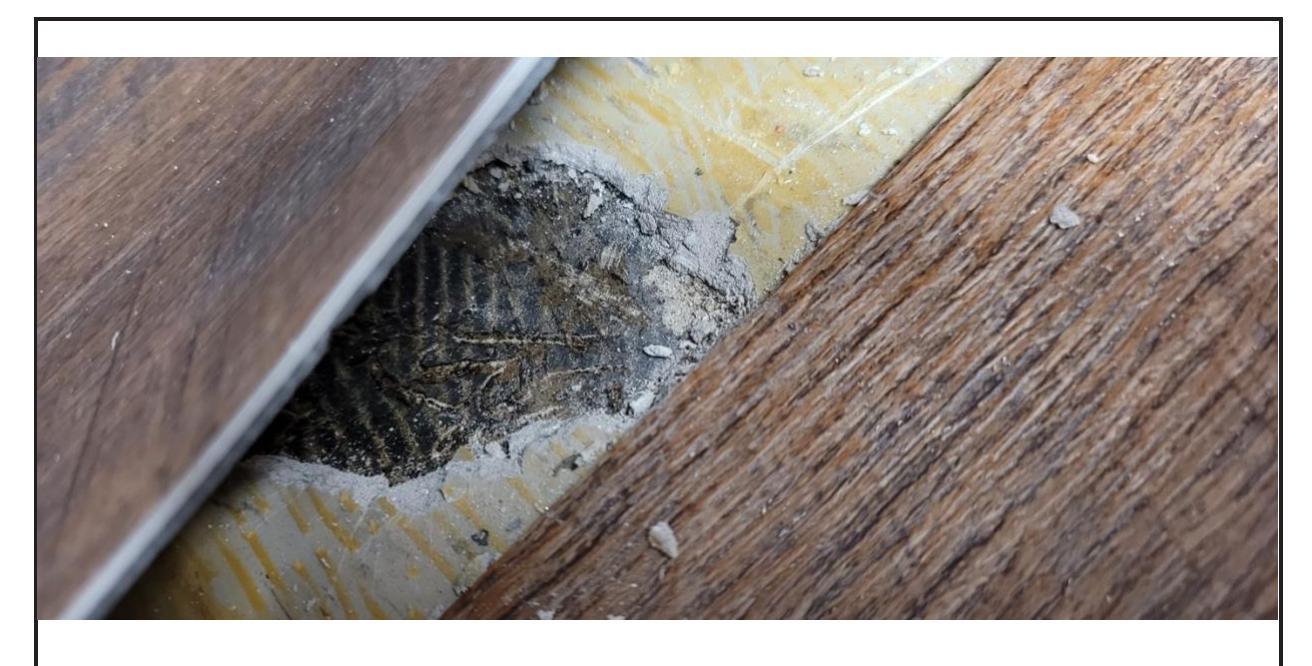
Photo 7: Asbestos-containing black/yellow mastic associated with beige floor tile under vinyl plank flooring (114).

The black mastic associated with beige floor tile located under vinyl plank flooring in 110 & 114 Areas was found to contain 3% chrysotile asbestos. The material was generally non-friable and in fair condition at the time of the inspection.

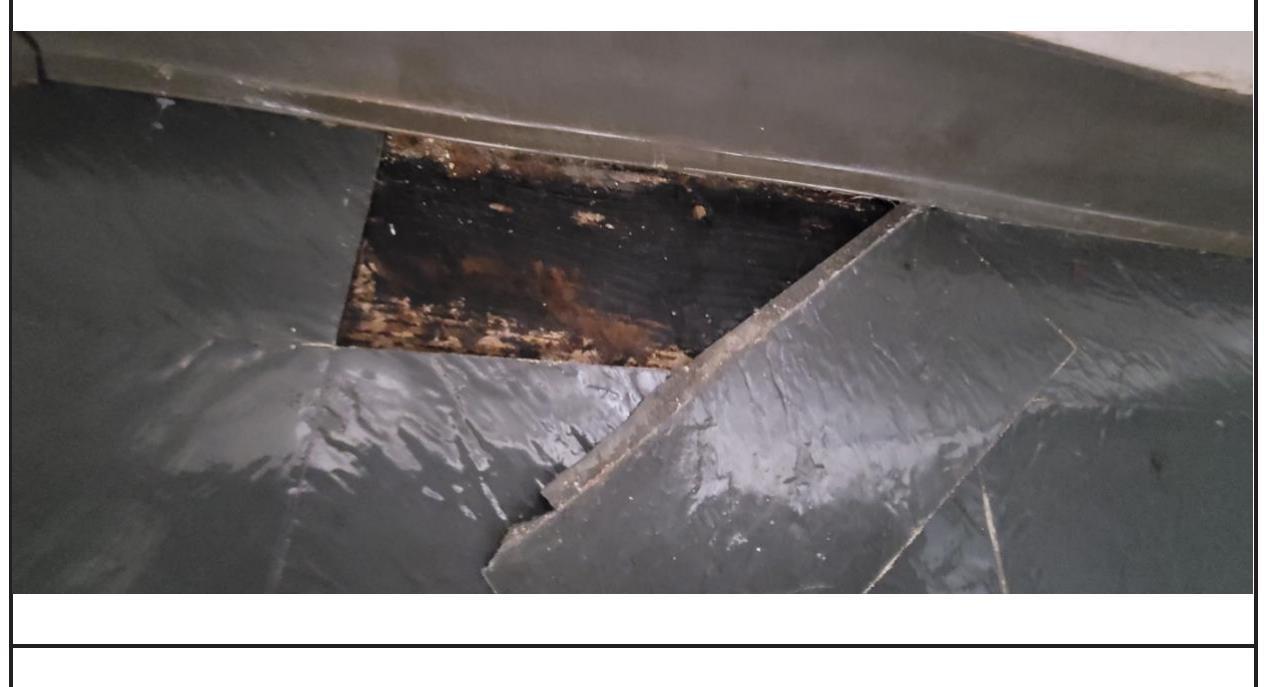
Photo 8: Asbestos-containing black mastic associated with gray floor tile (127A).

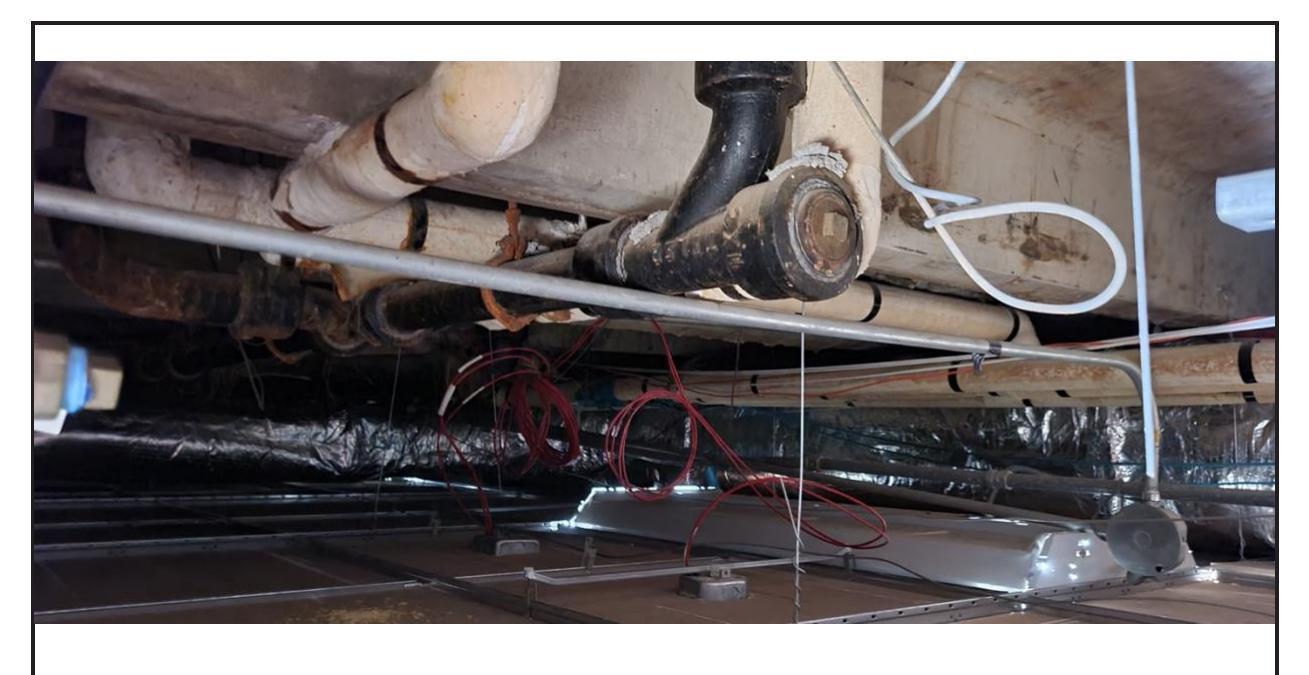
Photo 9: Asbestos-containing thermal system insulation (100).

The thermal system insulation located throughout was identified in a 2018 asbestos inspection to contain 15% chrysotile asbestos and 15% amosite asbestos. The material was generally non-friable and in fair condition. (Note: some localized damage was observed in 100 area above ceiling tiles)

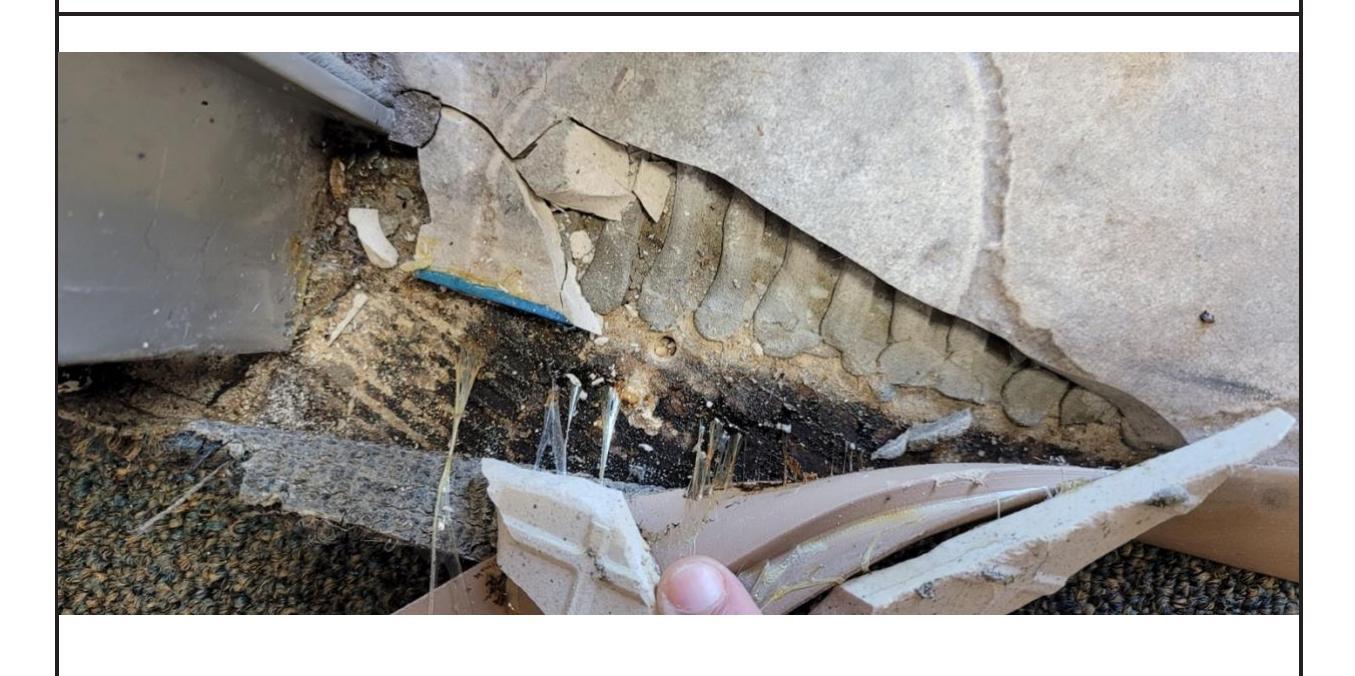
Photo 10: Asbestos-containing black mastic associated with gray ceramic tile (116).

The black mastic associated with gray ceramic tile in 116 was found to contain 5% chrysotile asbestos. The material was non-friable and in fair condition at the time of the inspection.

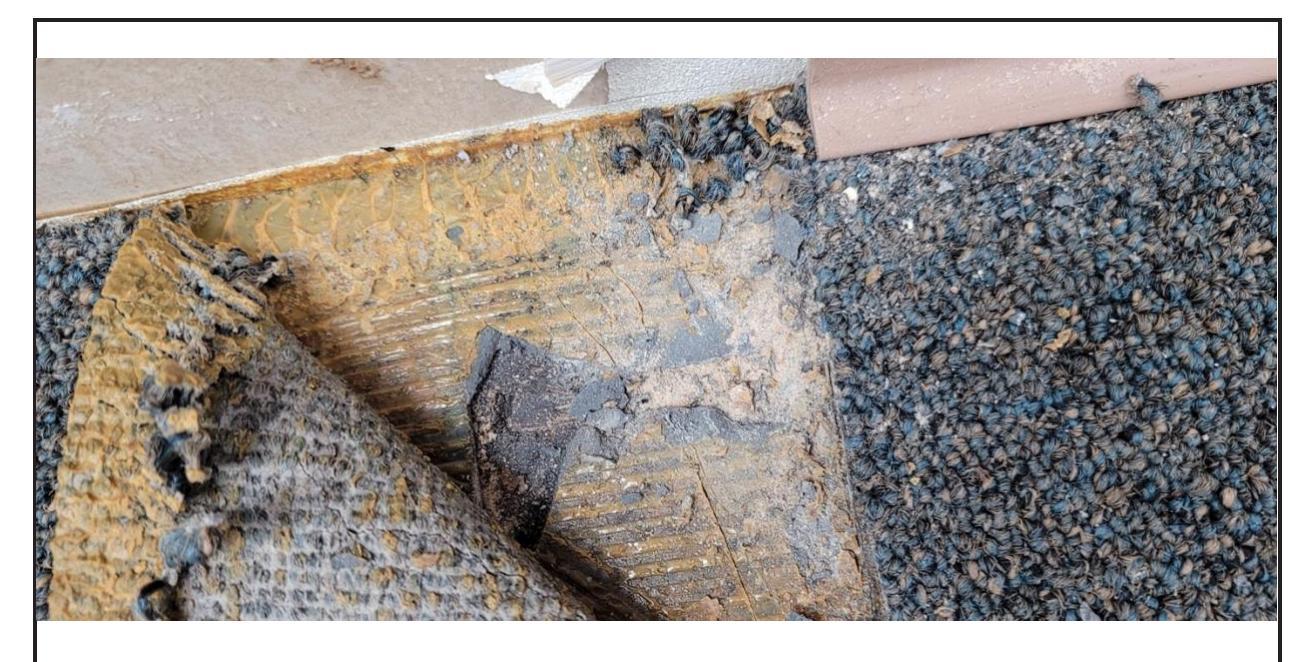
Photo 11: Asbestos-containing black mastic associated with gray floor tile under carpet (116).

The black mastic associated with gray floor tile located under carpet in some areas in west side of building was found to contain 5% chrysotile asbestos. The material was generally non-friable and in fair condition at the time of the inspection.

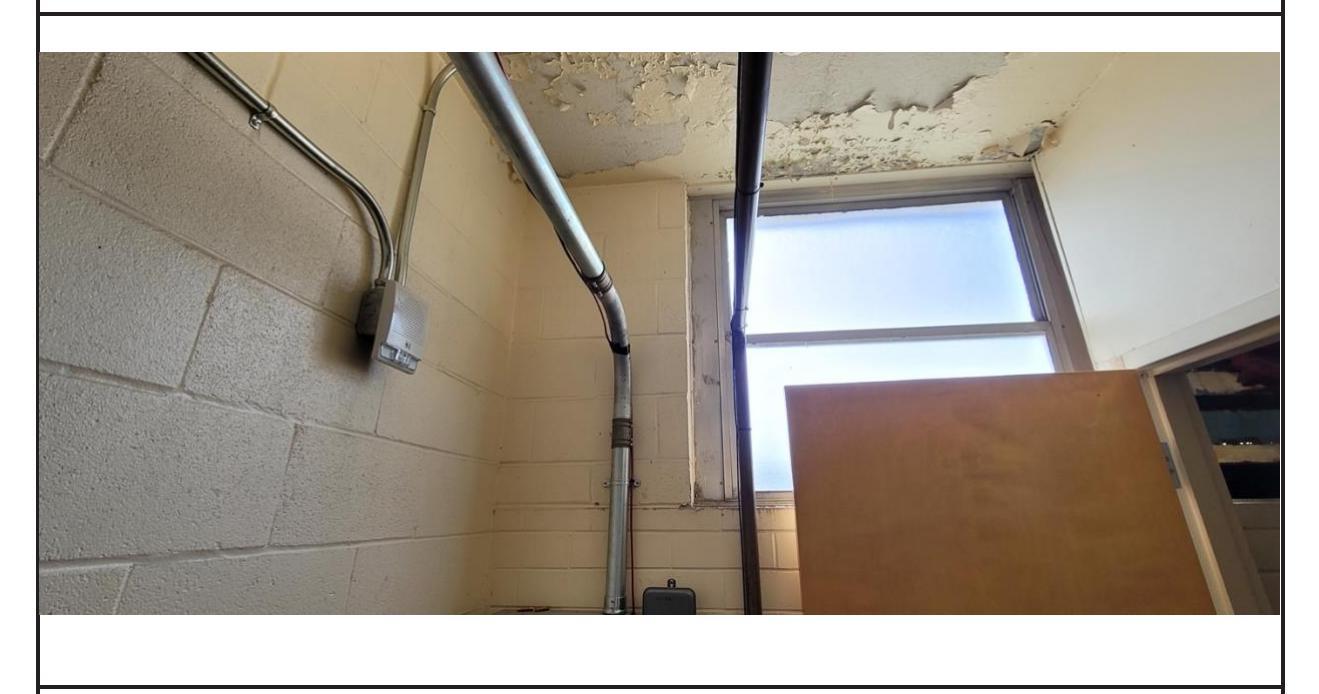
Photo 12: Asbestos-containing interior and exterior window caulk and exterior window glazing (116D).

The interior window caulk located throughout was found to contain 5% chrysotile asbestos. The material was non-friable and in good condition at the time of the inspection.

The exterior window and door caulk located throughout was identified in a 2018 asbestos inspection to contain 3% chrysotile asbestos. The material was generally non-friable and in fair condition at the time of inspection.

The exterior window glazing located throughout was identified in a 2018 asbestos inspection to contain 2% chrysotile asbestos. The material was generally non-friable and in fair condition at the time of inspection.

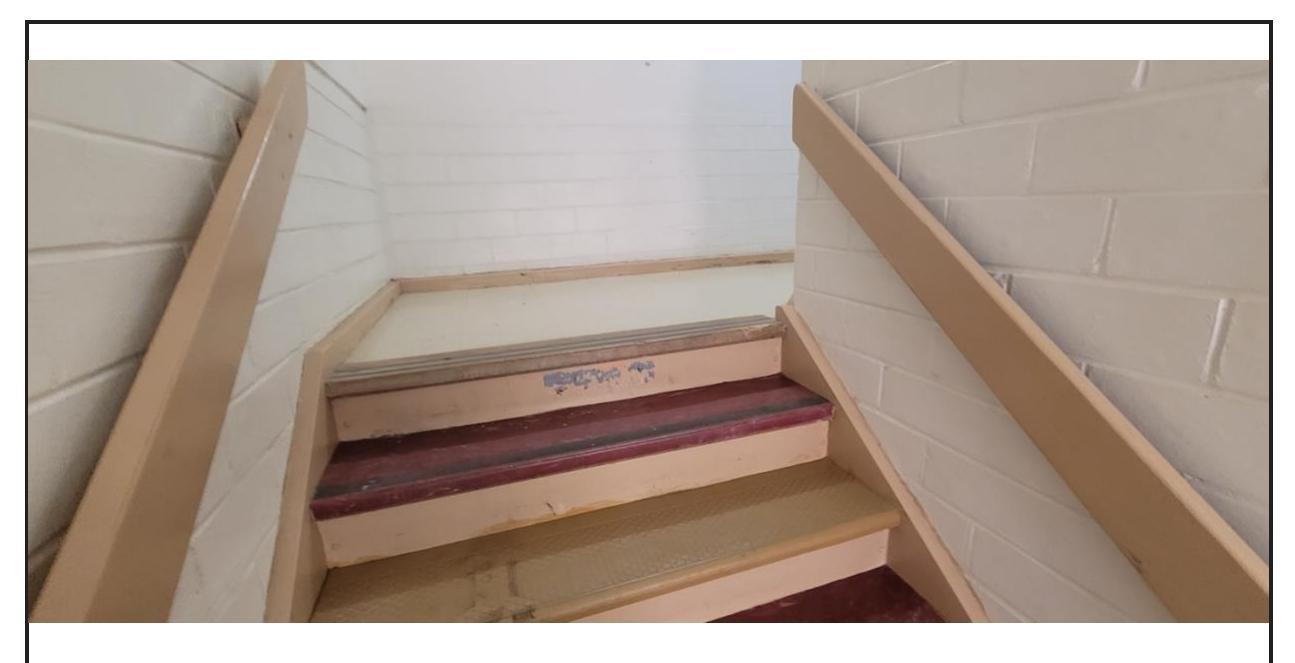
Photo 13: Asbestos-containing stairs caulk (100S1).

The stairs caulk located in Stairwells was found to contain 5% chrysotile asbestos. The material was generally non-friable and in fair condition at the time of the inspection.
