ACTIVE LEARNING CENTER

April 2024 · Final Report

A PROGRAM OF REQUIREMENTS FOR THE NEW ACTIVE LEARNING CENTER AT SAM HOUSTON STATE UNIVERSITY

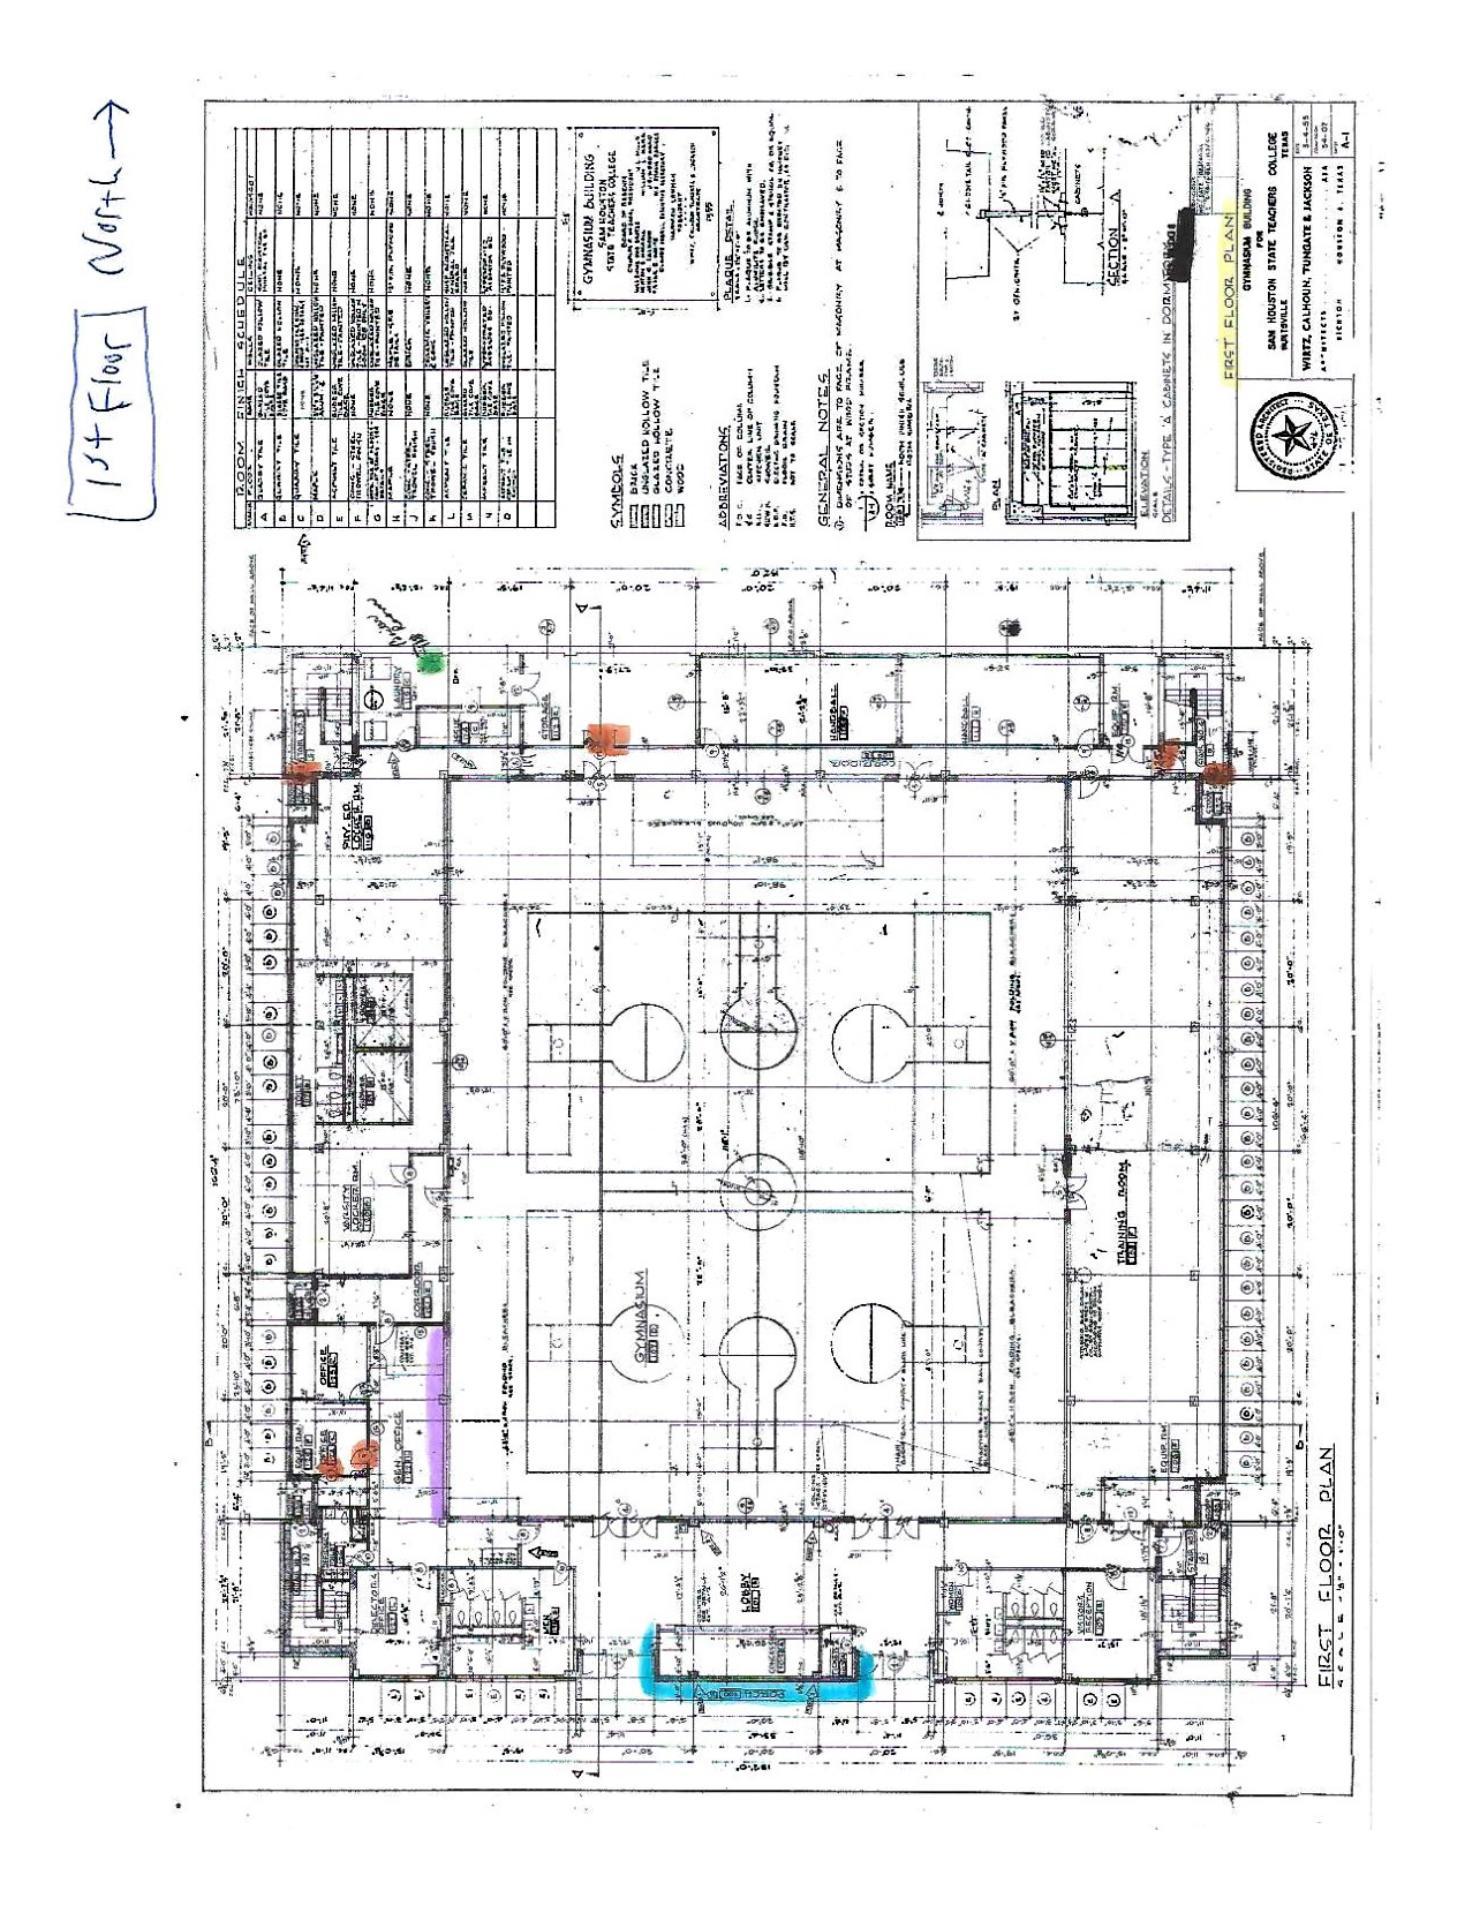
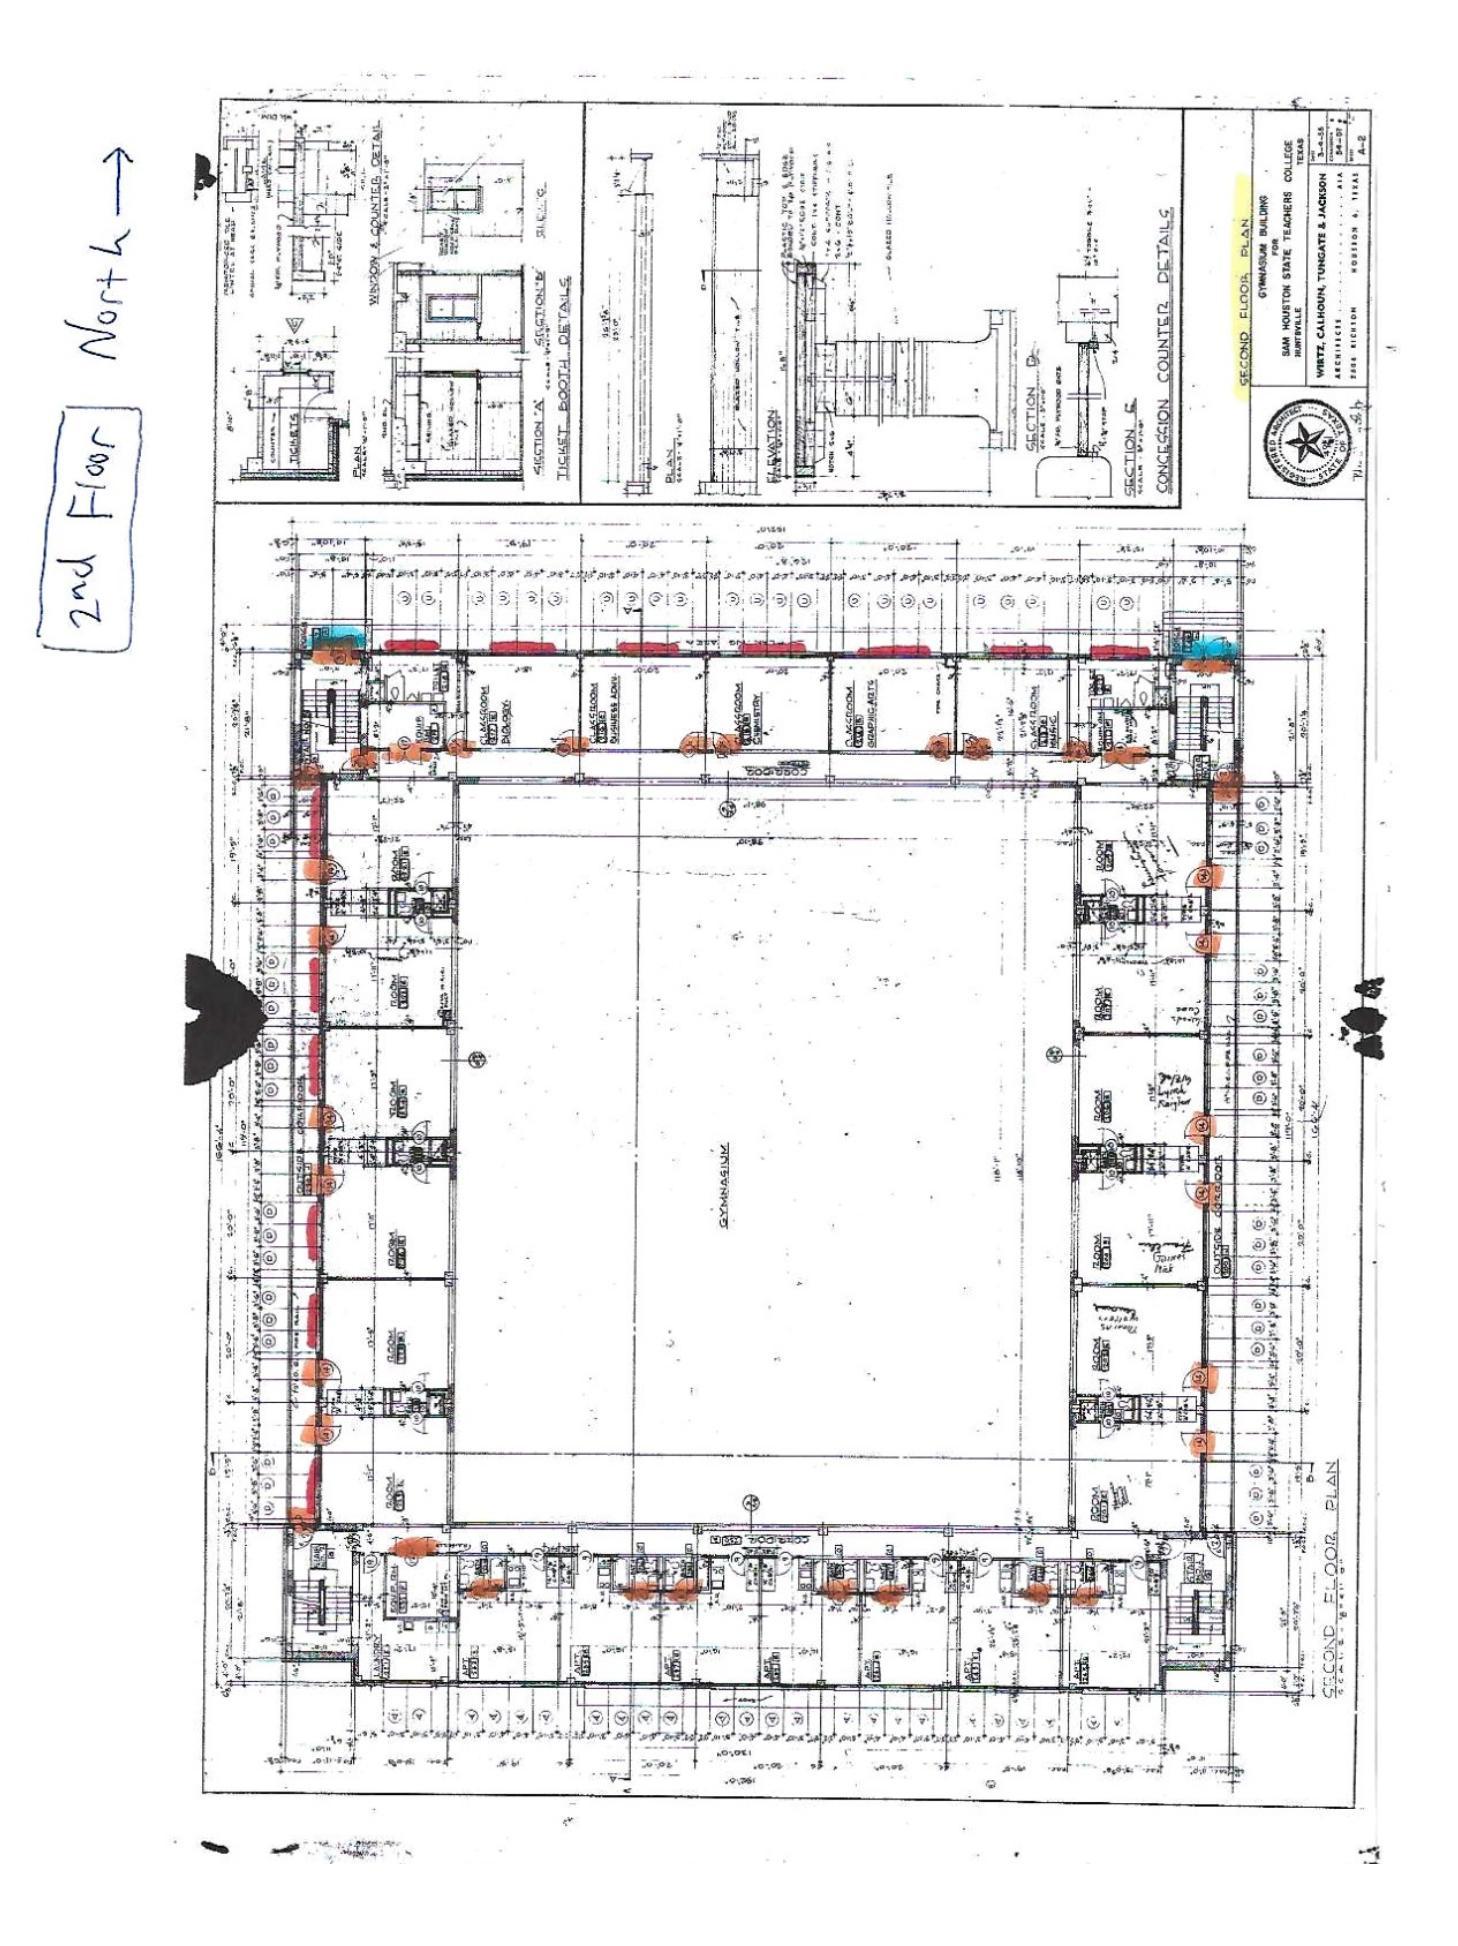
Legend for Lead-Based Paint Component Location Drawings

Highlighted components are approx. locations of representative components that tested positive for lead-based paint
= Interior brick block wall (appears isolated)
= Interior cast iron sinks (observed – possibly other sinks present)
= Interior / exterior metal or wood door system components (various doors, frames, lintels)
= Exterior metal window lintels (lintels are not present on all window systems)
= Exterior ceramic tile walls
